Able Electropolishing Co.
2001 S Kilbourn Ave
Chicago IL 60623
Phone: 773-277-1600

#1039 Brite Passivation

Industry: Aerospace - Manufacturers of aircraft seals

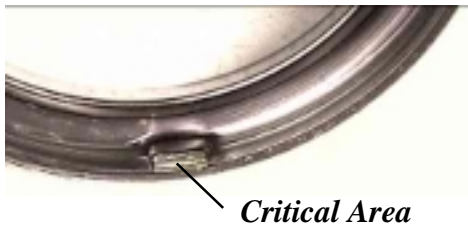
Problem: The customer was experiencing corrosion problems after brazing the two metals on the inside of the seal (see photo of critical area). The customer needed to remove the rust while still maintaining the integrity of the copper brazing material, and increase the corrosion protection of the part.

Solution: Electropolishing the inside of the seal removed the rust while keeping the copper braze intact. By removing the free iron at the braze joint, the electropolishing enhanced the corrosion resistance.
